1 **APPLICATION OF DIGITAL PHOTOGRAMMETRY TO ROCK CUT SLOPE DESIGN**  
2

24  
25 To reduce future maintenance along a rockfall-prone stretch of U.S. Highway 15 on Bald  
26 Eagle Mountain near South Williamsport, the Pennsylvania Department of Transportation  
27 proposed to remove an existing rockfall fence and modify the existing cut to provide a rock  
28 catchment ditch in order to mitigate the rockfall hazard.

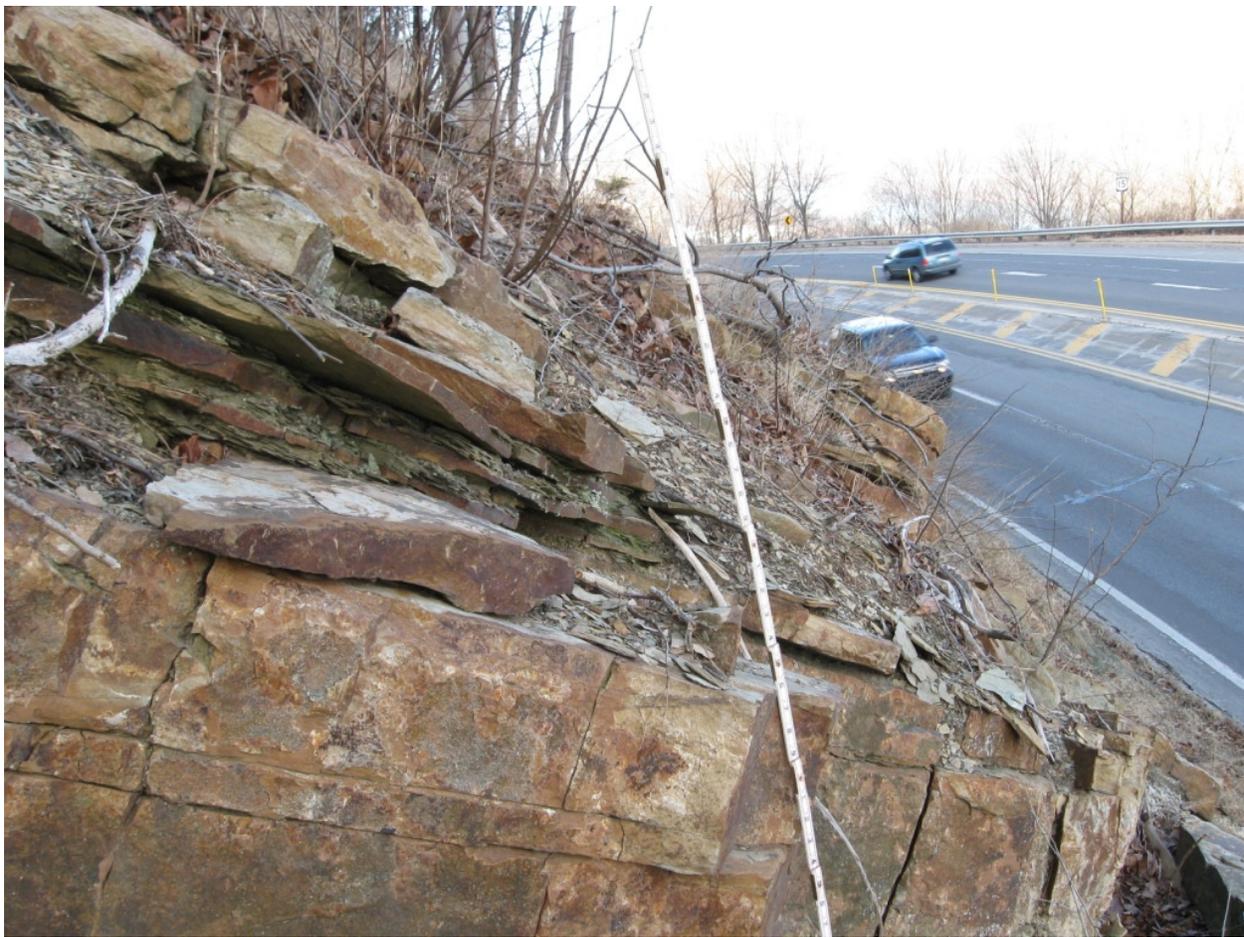
**FIGURE 1** Bedding, jointing, and differential weathering in existing rock cut.

45 Rockfalls have been a recurring problem on a curved portion of U.S. Highway 15 on Bald Eagle  
46 Mountain south of Williamsport, Pennsylvania. Conditions contributing to rockfalls include  
47 bedding planes dipping obliquely toward the roadway, joints dipping steeply into the cut  
48 providing an upper release surface, steeply dipping orthogonal joints providing lateral release  
49 surfaces, and undercutting of quartzite beds as a result of differential weathering of weaker shale  
50 and siltstone beds (Figure 1).

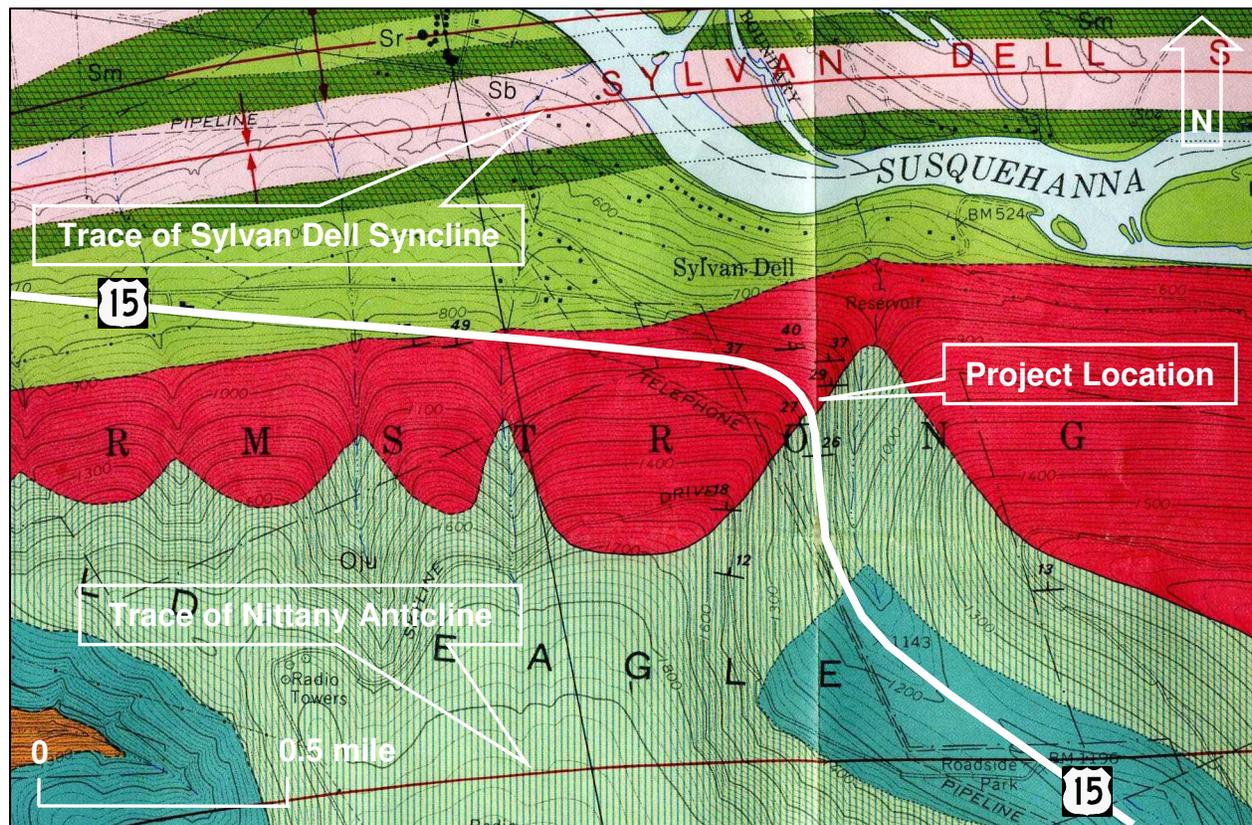
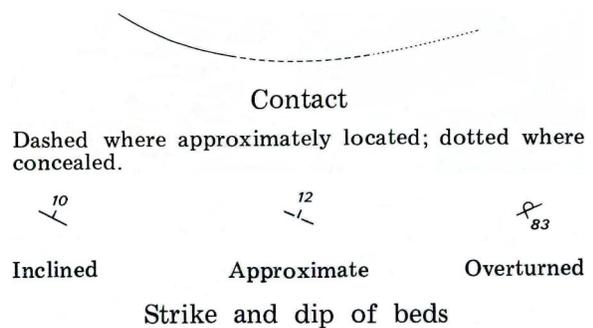
**FIGURE 3 Project geology (3).**

80 According to mapping published by the Pennsylvania Geological Survey (3), the project is  
 81 situated between the axial trace of the Nittany anticline to the south and the Sylan Dell syncline  
 82 to the north (Figure 3). The project straddles the contact between the Juniata Formation of the  
 83 Upper Ordovician system to the south and the Tuscarora Formation of the Lower Silurian system  
 84 to the north (3). According to Faill (4), these rocks formed from sediments deposited in the

85 Appalachian basin from a source area (the Taconic highlands) located to the southeast of the  
86 basin. The rocks generally consist of fine- to coarse-grained quartzite interbedded with very fine  
87 and fine-grained sandstone, siltstone, and shaly siltstone. The geologic mapping indicates that in  
88 the vicinity of the project, the bedrock strata dip approximately 26 to 37 degrees to the north.  
89 The area above the existing cut is State Forest Land and mantled with colluvium.

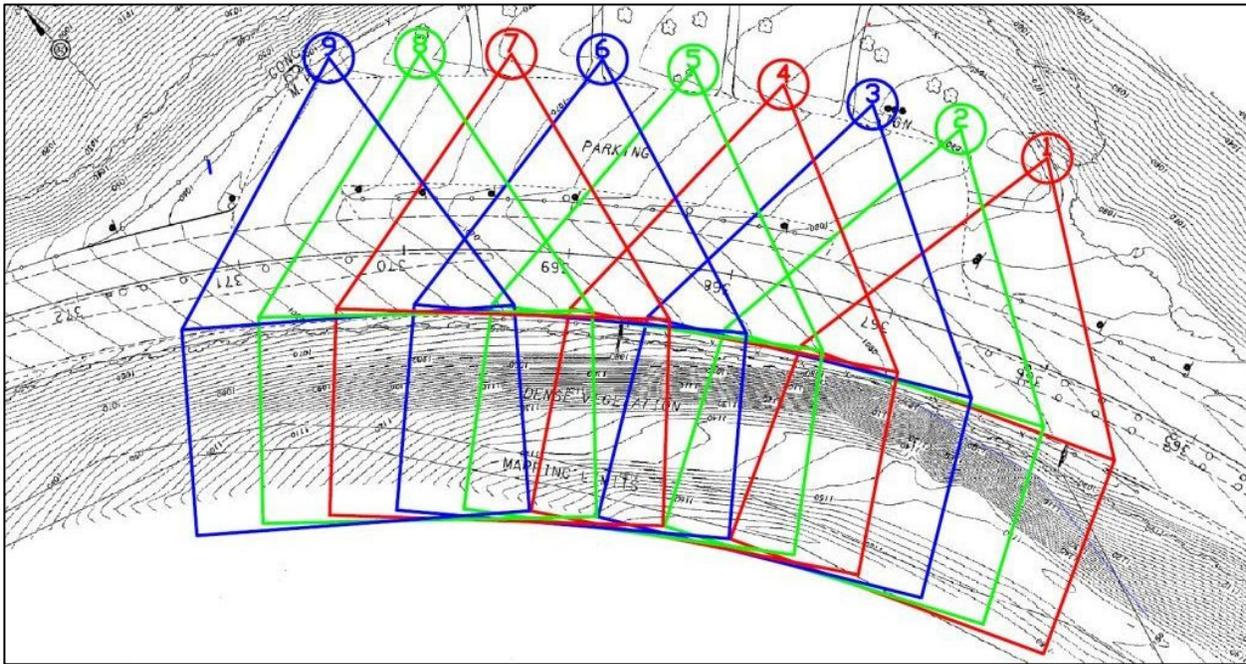
**FIGURE 4 Plan for shooting image strip model.**

131 Site topography restricted the distance from which the rock face could be photographed  
 132 (i.e., the object distance), so an image strip appeared to be the most feasible model in this case.  
 133 This model usually requires 60 percent horizontal overlap of the images; however, the amount of  
 134 overlap was slightly increased due to the curving nature of the alignment. The plan also sought  
 135 to keep the object distance the same for each camera location (approximately 50 meters). Based  
 136 on the anticipated object distance, a plan for shooting the rock face with a 50-mm lens from nine  
 137 locations was developed (Figure 4).  
 138

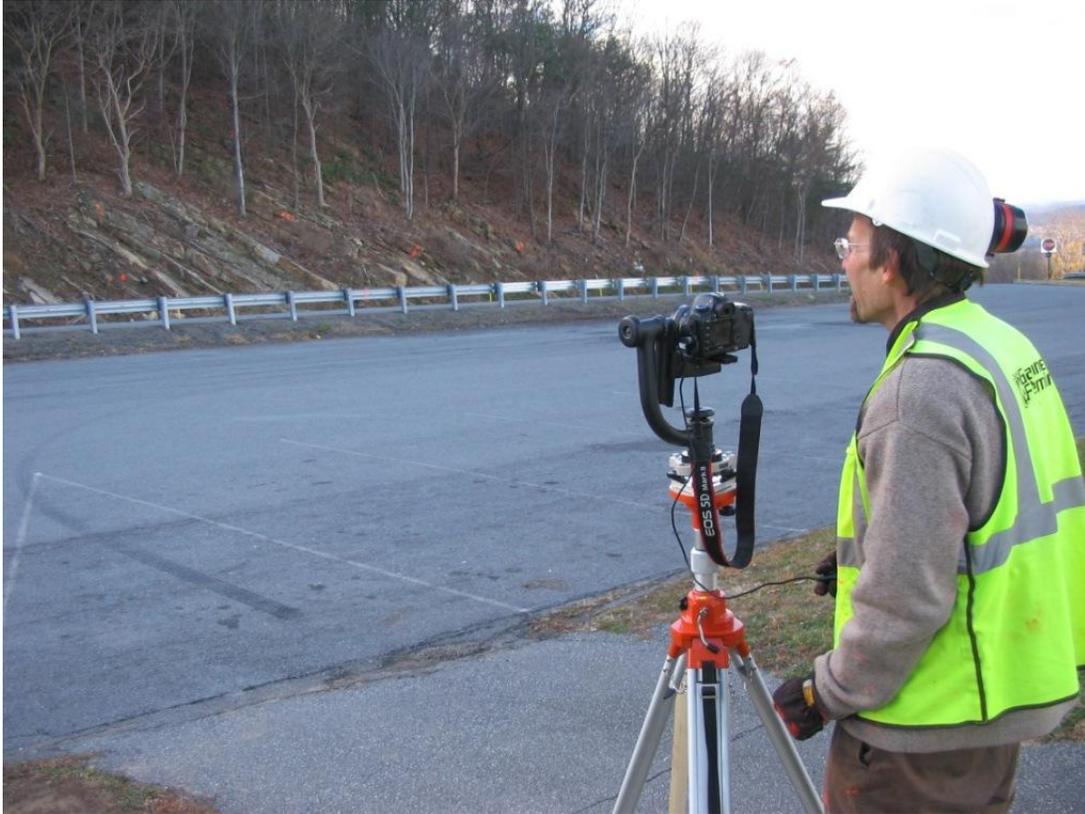
**FIGURE 5** Photographing the rock face.

149 Photographs were taken on the afternoon November 19, 2010. A tripod was used to steady the  
 150 camera, and a remote switch was used to activate the shutter and minimize movement of the  
 151 camera (Figure 5).

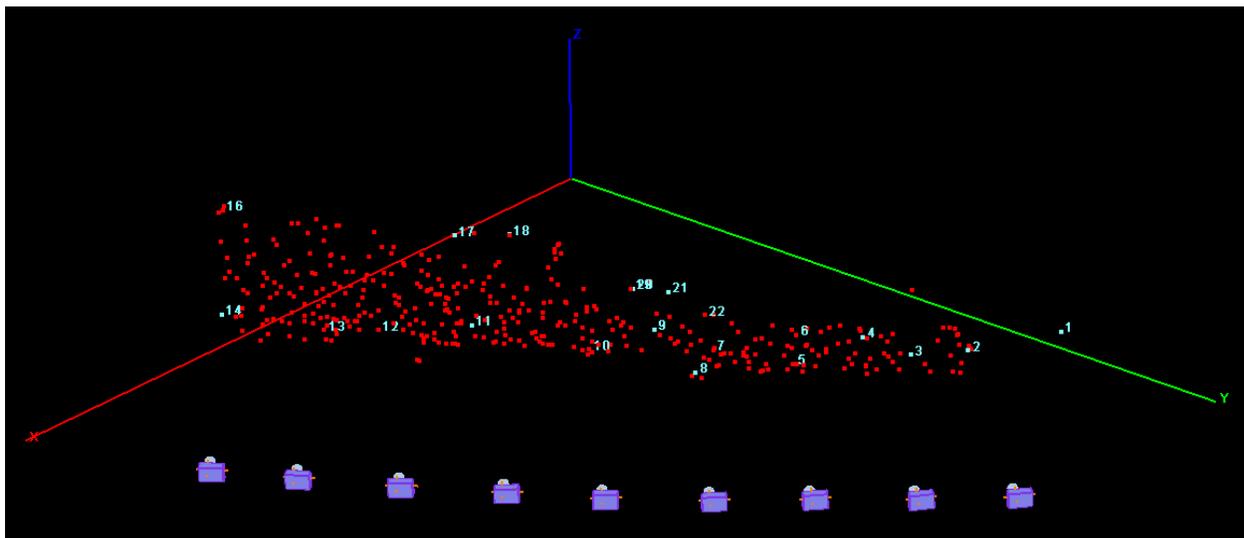
**FIGURE 6** Orientation of nine camera stations, matched points, and control points.

159 After the free network orientation was solved, surveyed control points were digitized, and an  
 160 absolute orientation was solved to tie the model to a real world coordinate system. Figure 6  
 161 illustrates the plotted locations of the camera stations (purple icons), the matched points (red  
 162 dots), the surveyed control points (teal dots), and the coordinate axes—northing, easting, and  
 163 elevation.

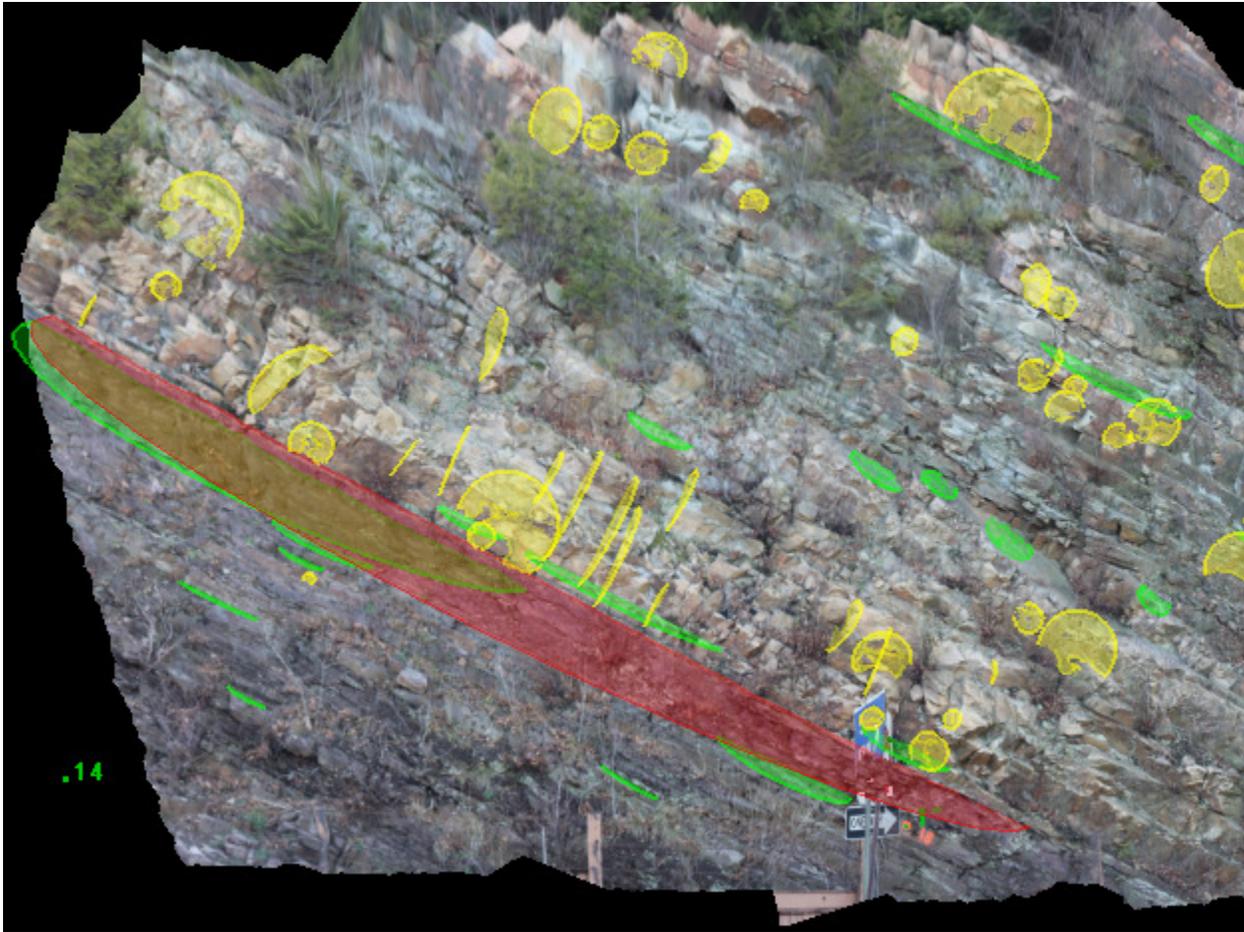
**FIGURE 8** Portion of digital model showing measured bedding joints (green disks); non-bedding joints (yellow disks), and the Tuscarora/Juniata contact (red disk). Red disk is 74.3 feet (22.6 meters) diameter.

185 tops of some more steeply dipping beds are evident in some locations in the model. These beds  
186 appear to be foreset beds.

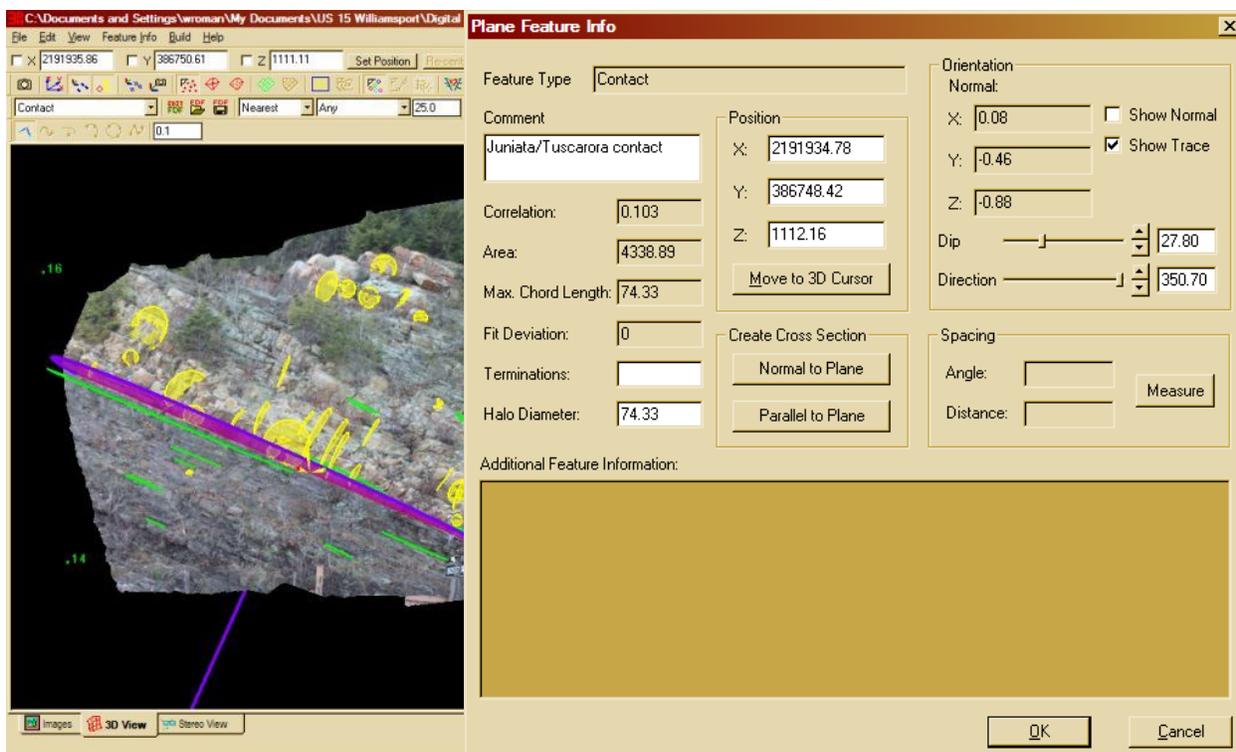
**FIGURE 9** Dialog box with selected feature information.

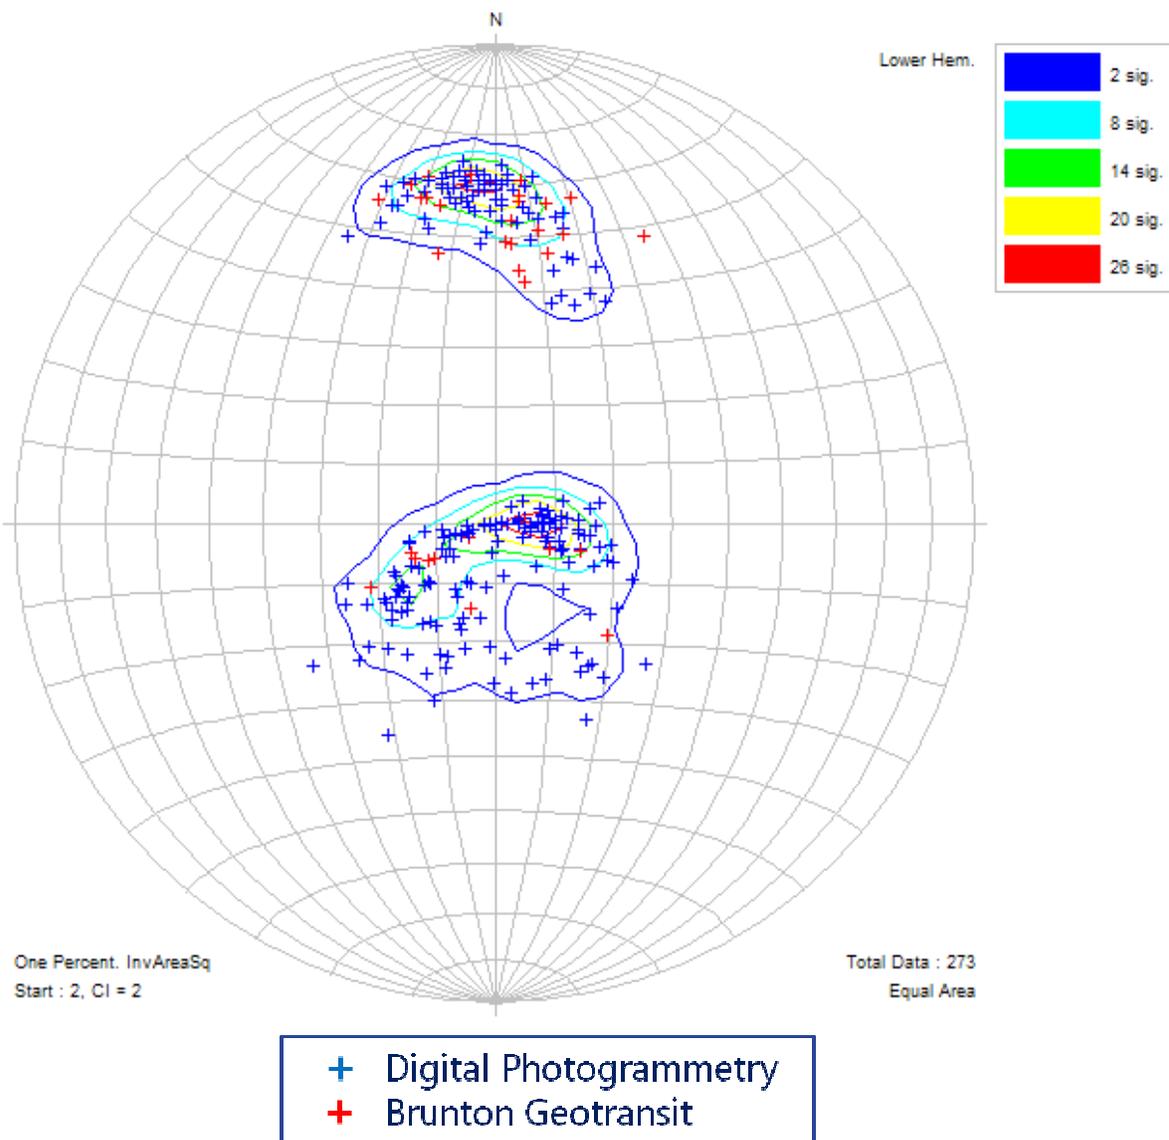
**FIGURE 10 Comparison of digital photogrammetry and manual measurements.**

189 Reconnaissance of the existing rock slope was performed following development of the model in  
190 order to collect additional data and validate the model. An additional 36 rock discontinuities  
191 were measured using a Brunton Geotransit with the magnetic declination set to 11.5 degrees  
192 west. Measurements were collected from areas north and south of the limits of the digital  
193 photogrammetry model and the area behind the existing wall. Some large, conspicuous faces  
194 within the model area were also measured for model validation. Figure 10 provides a stereonet  
195 plot of the dip vectors of the discontinuity orientations measured using the digital photo model  
196 and measured using the Brunton Geotransit. The digital photogrammetry measurements  
197 compare favorably with the manual measurements.

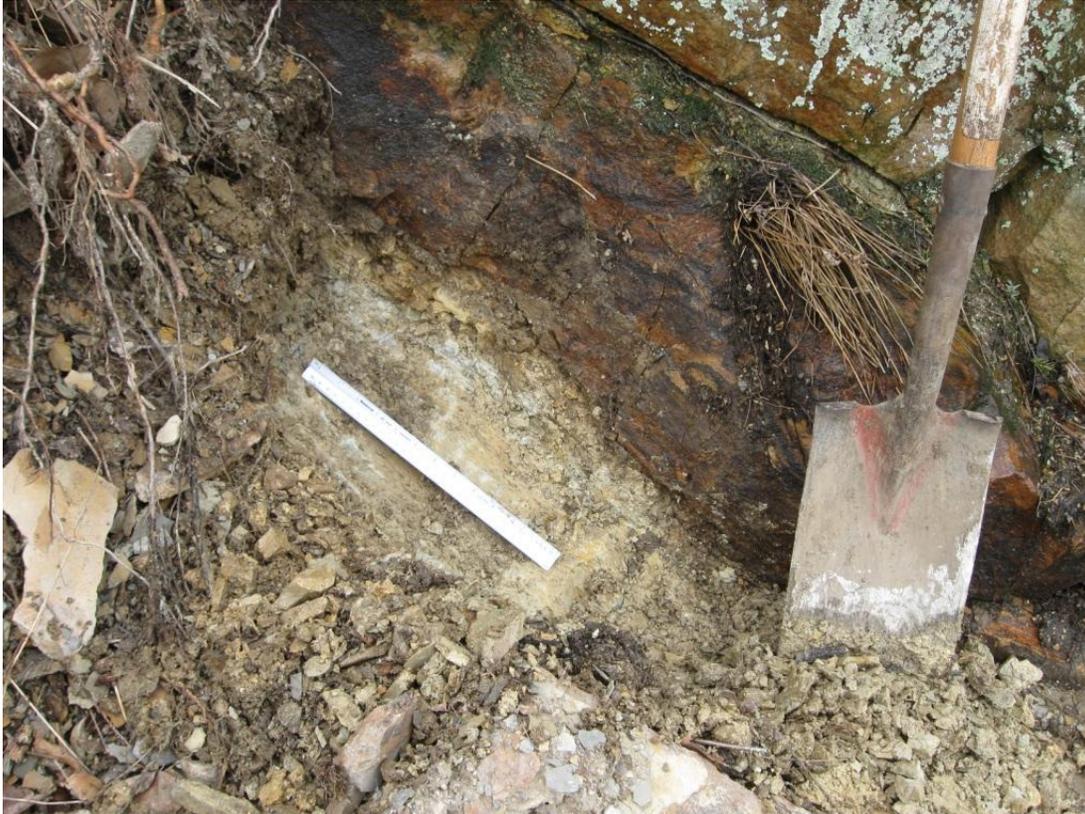
**FIGURE 11** Weathered shale bed possibly correlating with clay seam encountered in test boring.

198 Additional reconnaissance was performed to examine the outcrop for clay seams  
199 encountered in test borings performed as part of the subsurface investigation. Projecting the clay  
200 seams to the surface of the digital image was useful in identifying the possible location of the  
201 clay seams in the outcrop face (Figure 11). Reconnaissance also permitted collection of

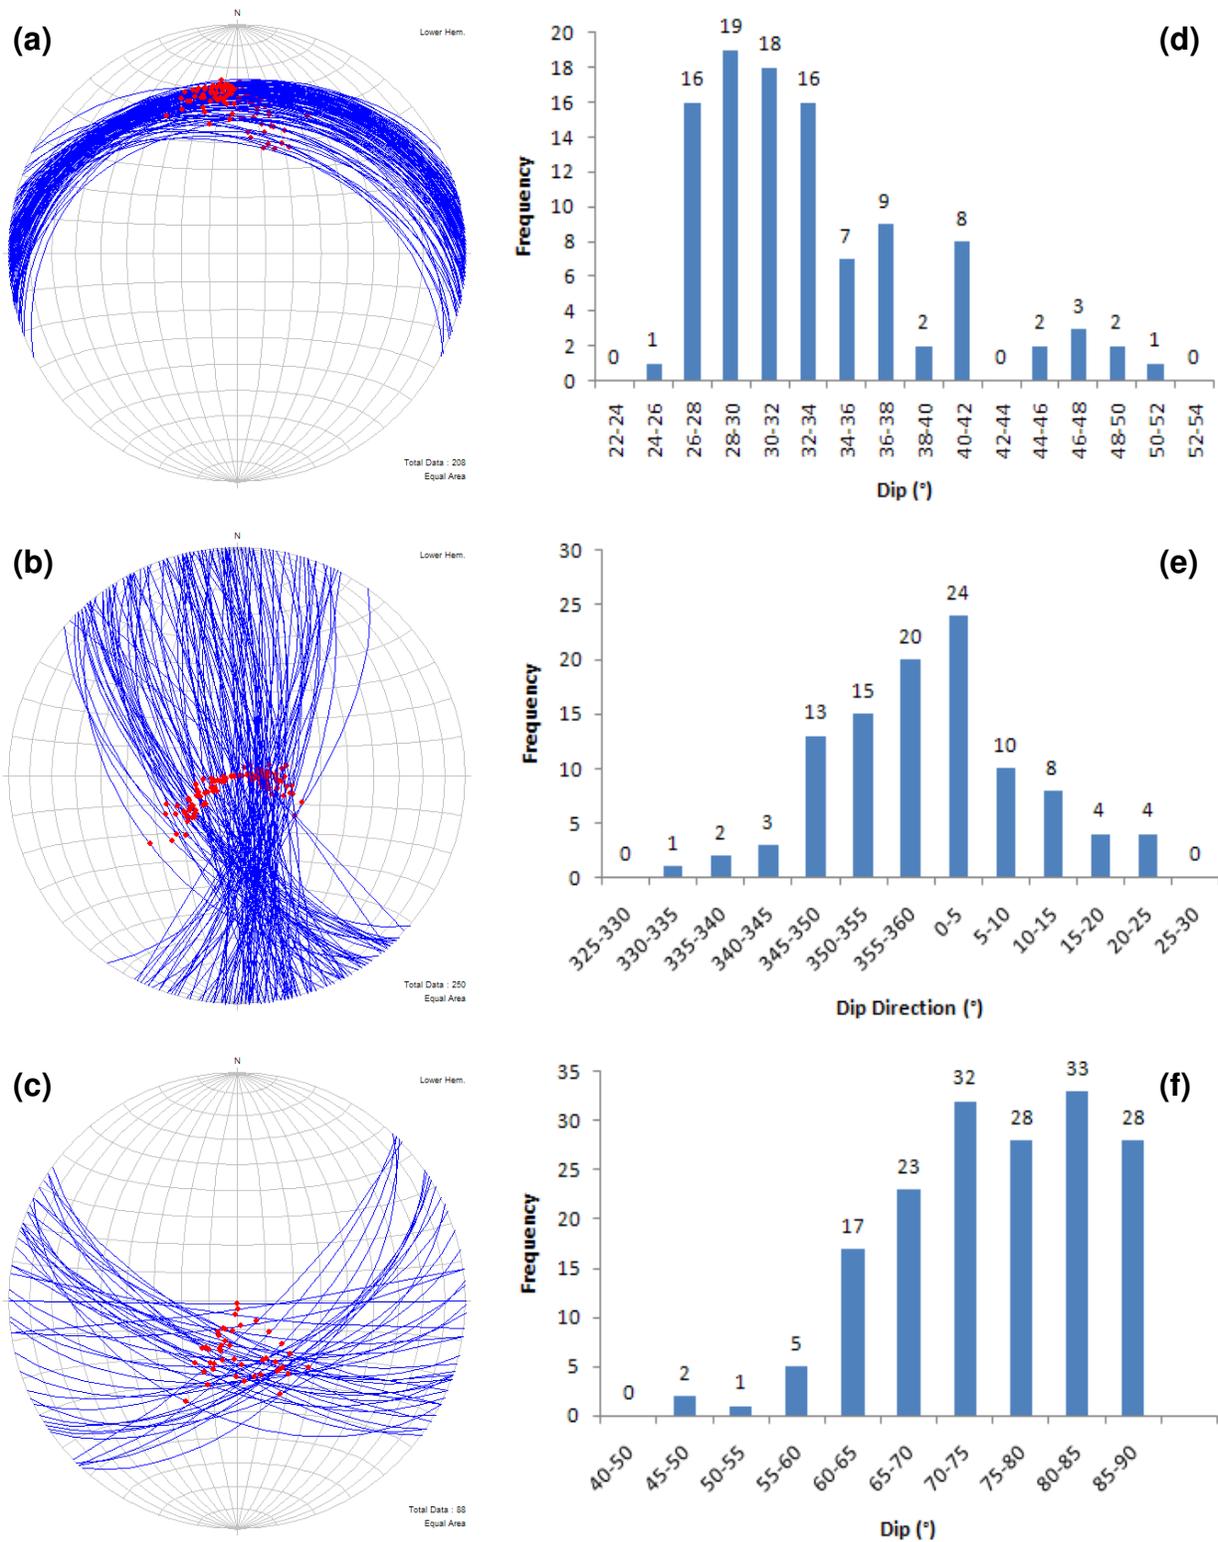
**FIGURE 12** Great circles (blue lines) and dip vectors (red dots) of (a) joint set 1 (bedding), (b) joint set 2, and (c) joint set 3. Histogram analyses of (d) bedding dip angle, (e) bedding dip direction, and (f) jointing dip angle.

207 Discontinuities of two types were identified—bedding joints (including the contact between the  
 208 Tuscarora and Juniata Formations) and two sets of steeply dipping joints. The great circles and  
 209 dip vectors corresponding to the 273 measurements taken on the three joint sets are plotted on  
 210 stereonets in Figure 12. Joint set 1 consists of bedding joints dipping to the north. Joint set 2  
 211 consists of joints striking north-south and dipping steeply to the east and west, and joint set 3  
 212 consists of joints striking east-west and dipping steeply to the south. Histogram analyses of  
 213 bedding dip angle and dip direction and jointing dip angle are also provided in Figure 12.

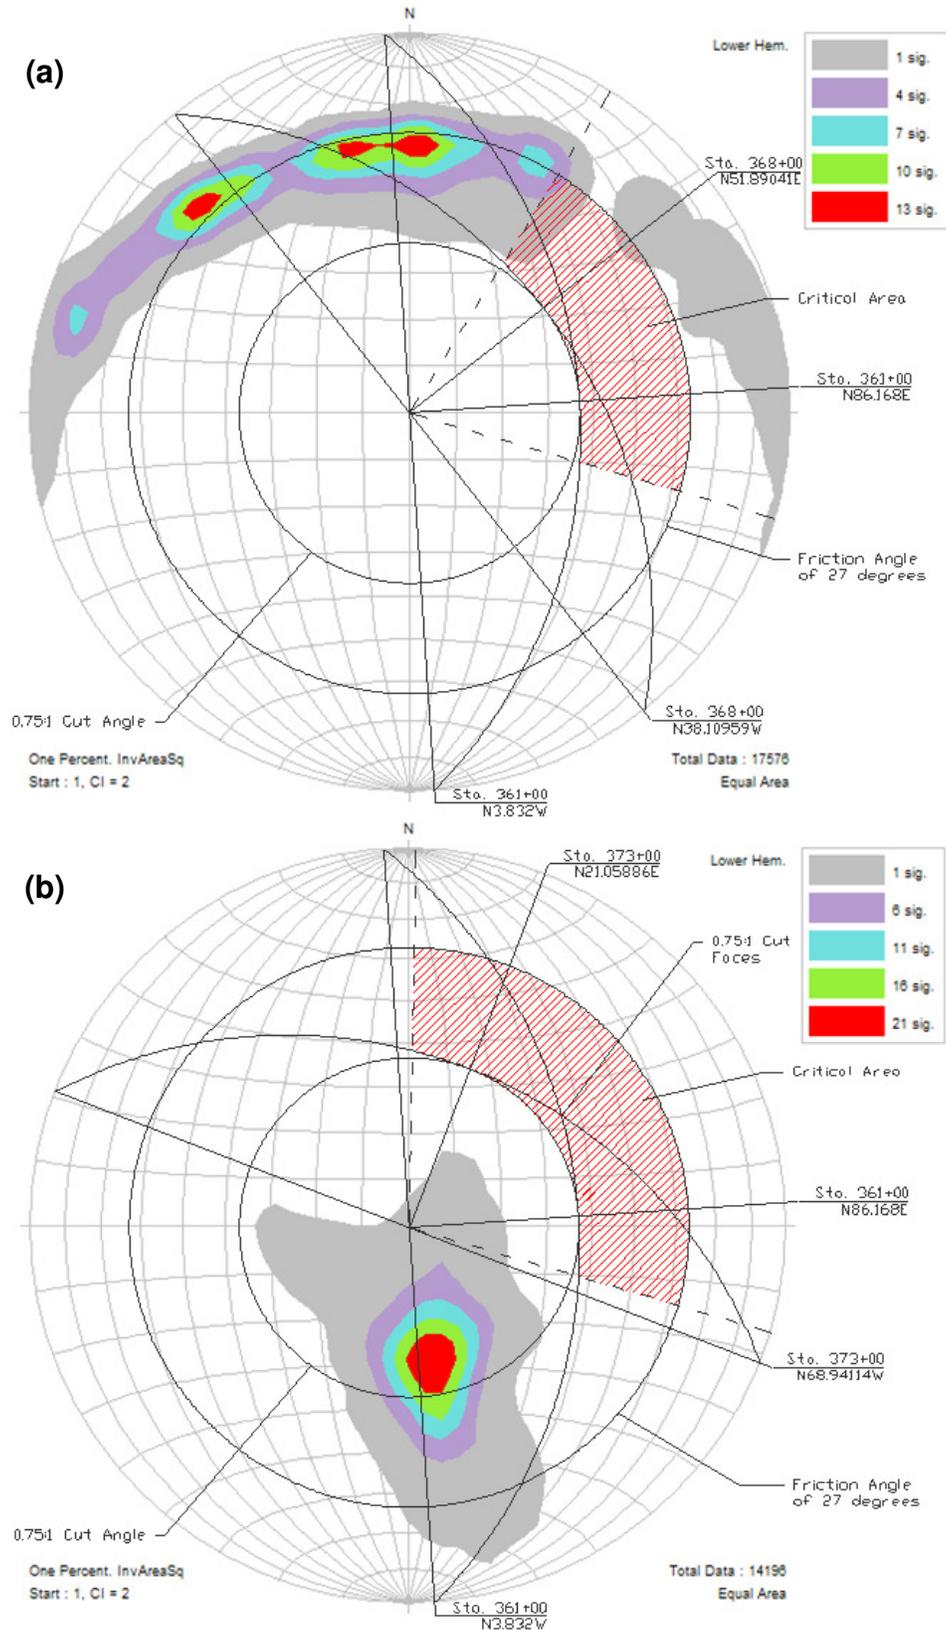
**FIGURE 13 Kinematic analyses for wedge failures using contour density plots of lines of intersections between (a) bedding and jointing, and (b) joint sets 2 and 3.**

225 The potential for planar and toppling failure was assessed by using stereonet to plot  
 226 discontinuity dip vectors and to identify the critical area associated with varying cut slopes and  
 227 slope directions along the curved highway alignment. To assess wedge failures, a matrix of  
 228 vector cross product equations was solved to determine the lines of intersections between  
 229 bedding and jointing and between the east-west and north-south striking joints. A contour plot of  
 230 the lines of intersections was used to assess the kinematic potential for wedge failure for  
 231 alternate cut slope designs (Figure 13).

232 The stereonet analyses were generally favorable with respect to the principal components  
 233 of bedding and jointing; however the analyses indicated planar and wedge failures are  
 234 kinematically possible at the fringes of the discontinuity sets toward the northern end of the  
 235 study area, and toppling is a possibility, particularly in the steeper portions of the northern half of  
 236 the study area.  
 237
